IC-706 Modifications & Fixes

FM Transmit Fix

(This article appeared in "Six News" Issue 59 and "Radio & Communications" April 1999)

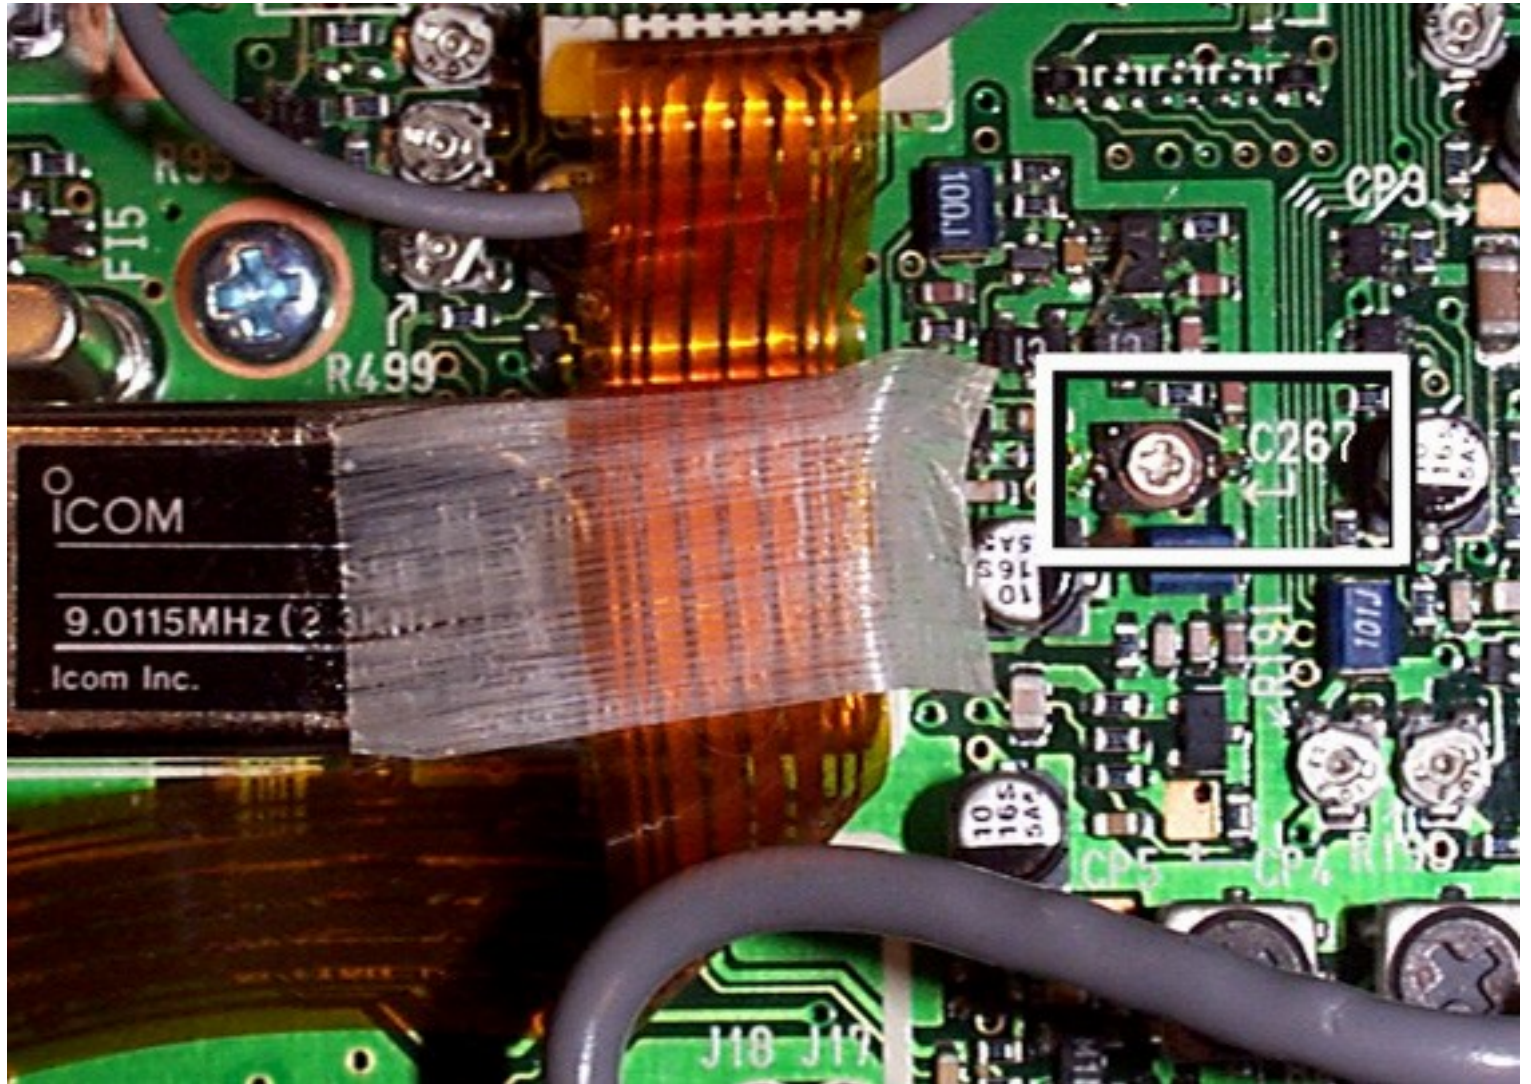
- Very low Output power (enough to be heard on a nearby receiver on the shack bench but that's about it).
- Carrier frequency is NOT what the dial indicates, typically 5 - 30kHz on the low side.
- Carrier tends to wander and sounds spurious.

I discovered that C267 a miniature SMT trimmer capacitor located 9mm to the right of the 9.0115 MHz IF Filter on the Main Unit - refer to picture - was not re-flow soldered to the PCB to a satisfactory standard. ie; There was insufficient solder paste applied during the printing process and the end result being a poor solder joint and an intermittent 9MHz VCO.

4. Locate the 9.0115 MHz IF filter and then C267 (identified on silkscreen) 9mm to the right of the filter.
5. Using fresh solder, carefully re-touch up solder joints to both pins of the trimmer cap. The filter side is difficult to solder due to nearby capacitors and the fact that the ground plane will sink a lot of heat. This is the pin that is usually not soldered properly ex the factory.

After re-touching both pins of C267 with fresh solder it's performed faultlessly since.

Although access to the offending area is easy you will need a very fine tip on your iron to get to the trimmer pin on the filter side without damaging the capacitor itself and disturbing two nearby 0603 chip capacitors. I cannot stress enough to successfully carry this repair out you need a very very fine tipped soldering iron, and ensure the tip is in good order.
